Summary of Issues and Concerns for Powerline FRS

Summary of Issues and Concerns for Vineyard Road FRS

Summary of Issues and Concerns for Rittenhouse FRS

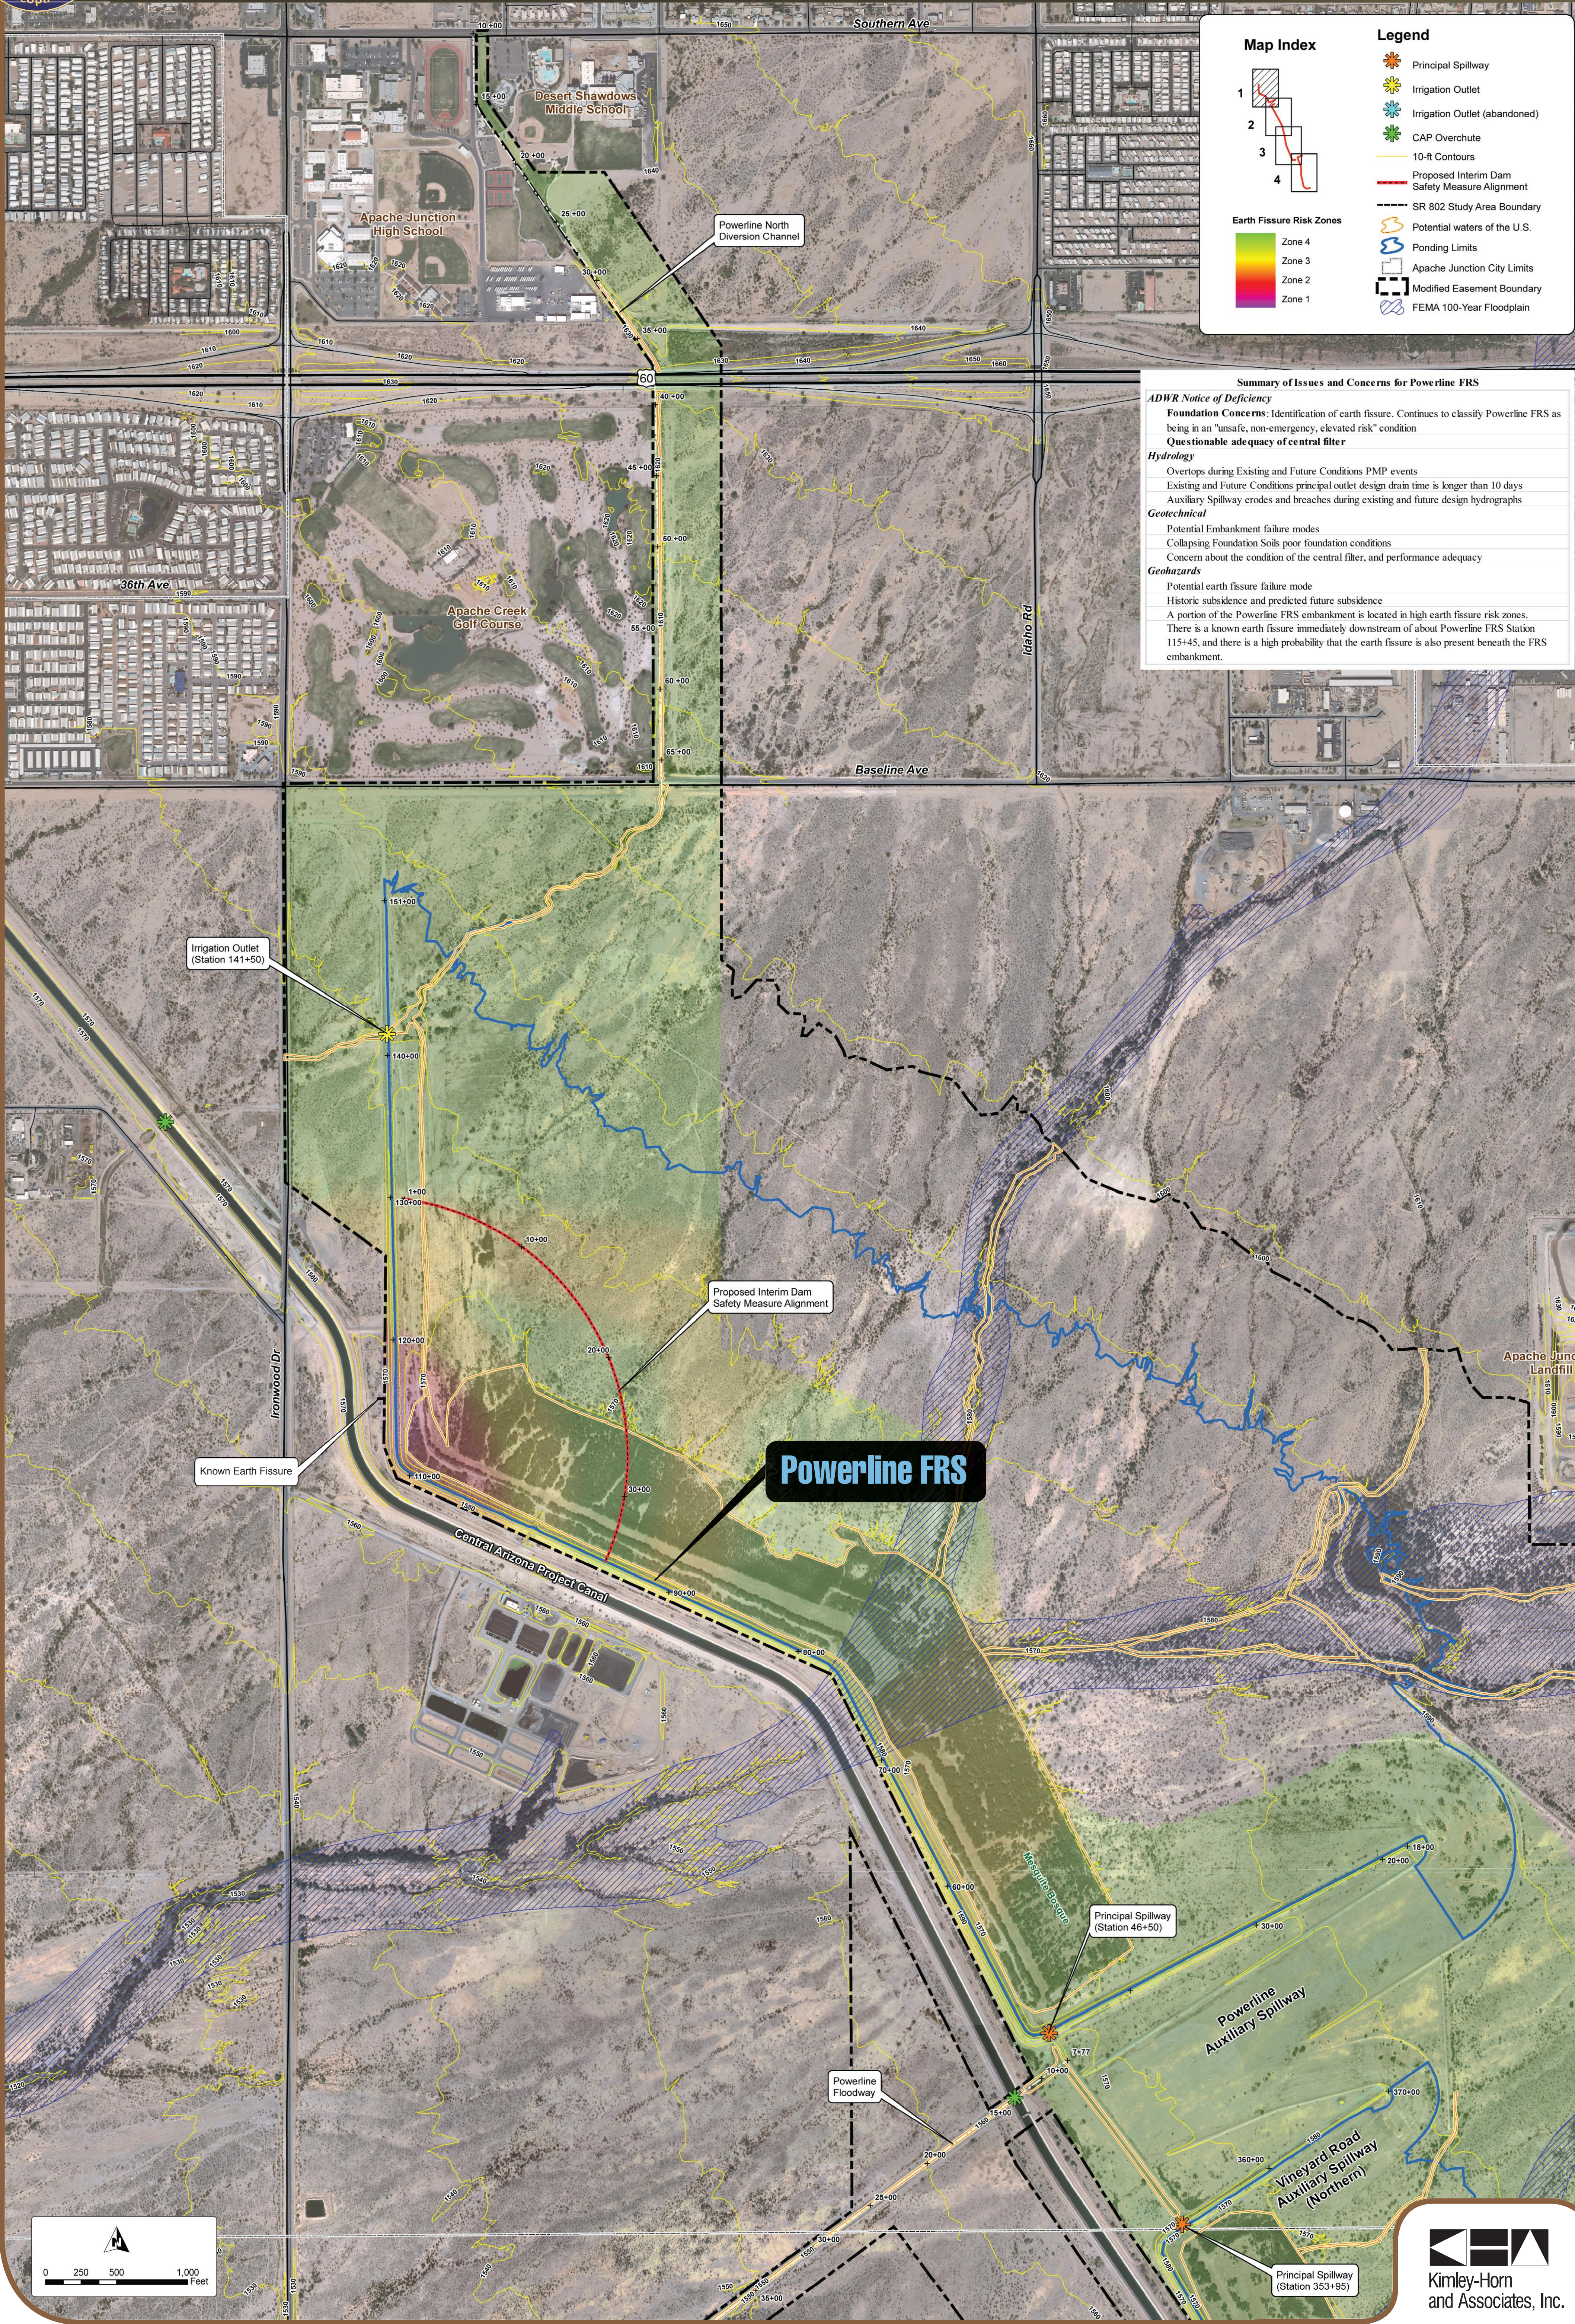
Foundation Concerns: Identification of earth fissure. Continues to classify Powerline FRS as being in an "unsafe, non-emergency, elevated risk" condition

Questionable adequacy of central filter

Overtops during Existing and Future Conditions PMP events

Existing and Future Conditions principal outlet design drain time is longer than 10 days

Auxiliary Spillway erodes and breaches during existing and future design hydrographs

Collapsing Foundation Soils poor foundation conditions

Concern about the condition of the central filter, and performance adequacy

Potential earth fissure failure mode

Historic subsidence and predicted future subsidence

A portion of the Powerline FRS embankment is located in high earth fissure risk zones.

There is a known earth fissure immediately downstream of about Powerline FRS Station 115+45, and there is a high probability that the earth fissure is also present beneath the FRS embankment.

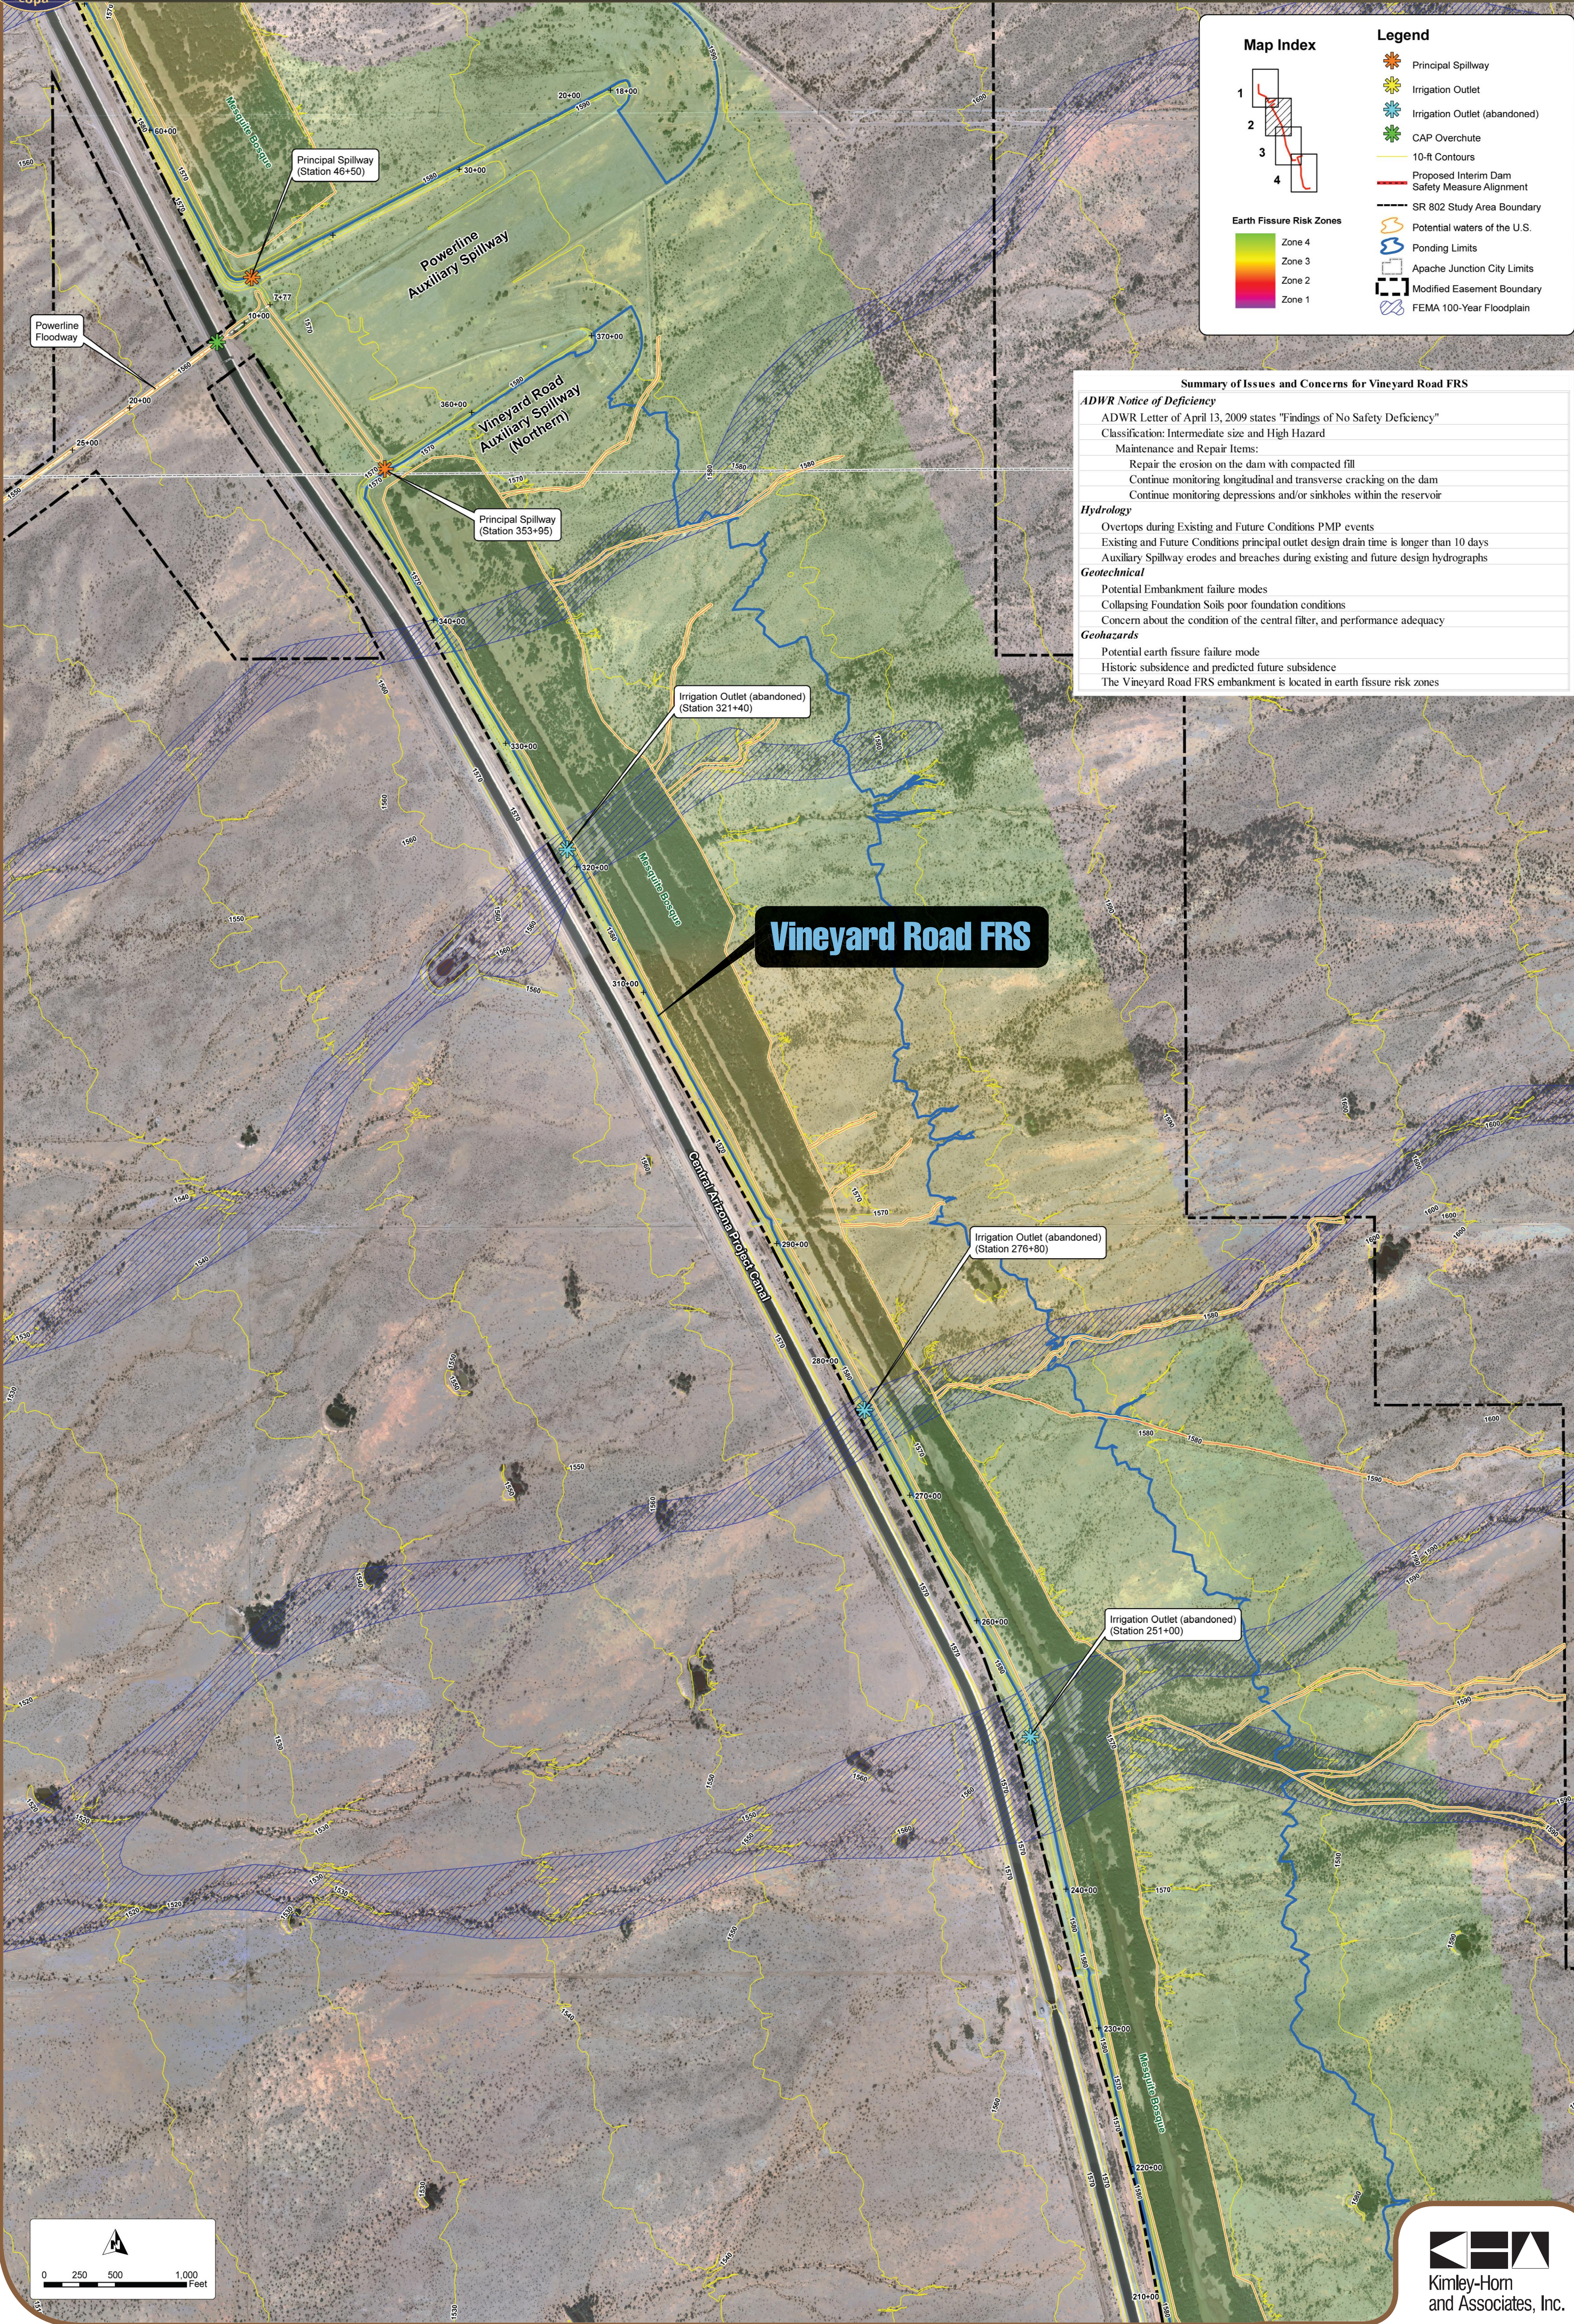
Summary of Issues and Concerns for Vineyard Road FRS	
ADWR Notice of Deficiency	
ADWR Letter of April 13, 2009 states "Findings of No Safety Deficiency"	
Classification: Intermediate size and High Hazard	
Maintenance and Repair Items:	
Repair the erosion on the dam with compacted fill	
Continue monitoring longitudinal and transverse cracking on the dam	
Continue monitoring depressions and/or sinkholes within the reservoir	
Hydrology	
Overtops during Existing and Future Conditions PMP events	
Existing and Future Conditions principal outlet design drain time is longer than 10 days	
Auxiliary Spillway erodes and breaches during existing and future design hydrographs	
Geotechnical	
Potential Embankment failure modes	
Collapsing Foundation Soils poor foundation conditions	
Concern about the condition of the central filter, and performance adequacy	
Geohazards	
Potential earth fissure failure mode	
Historic subsidence and predicted future subsidence

The Vineyard Road FRS embankment is located in earth fissure risk zones

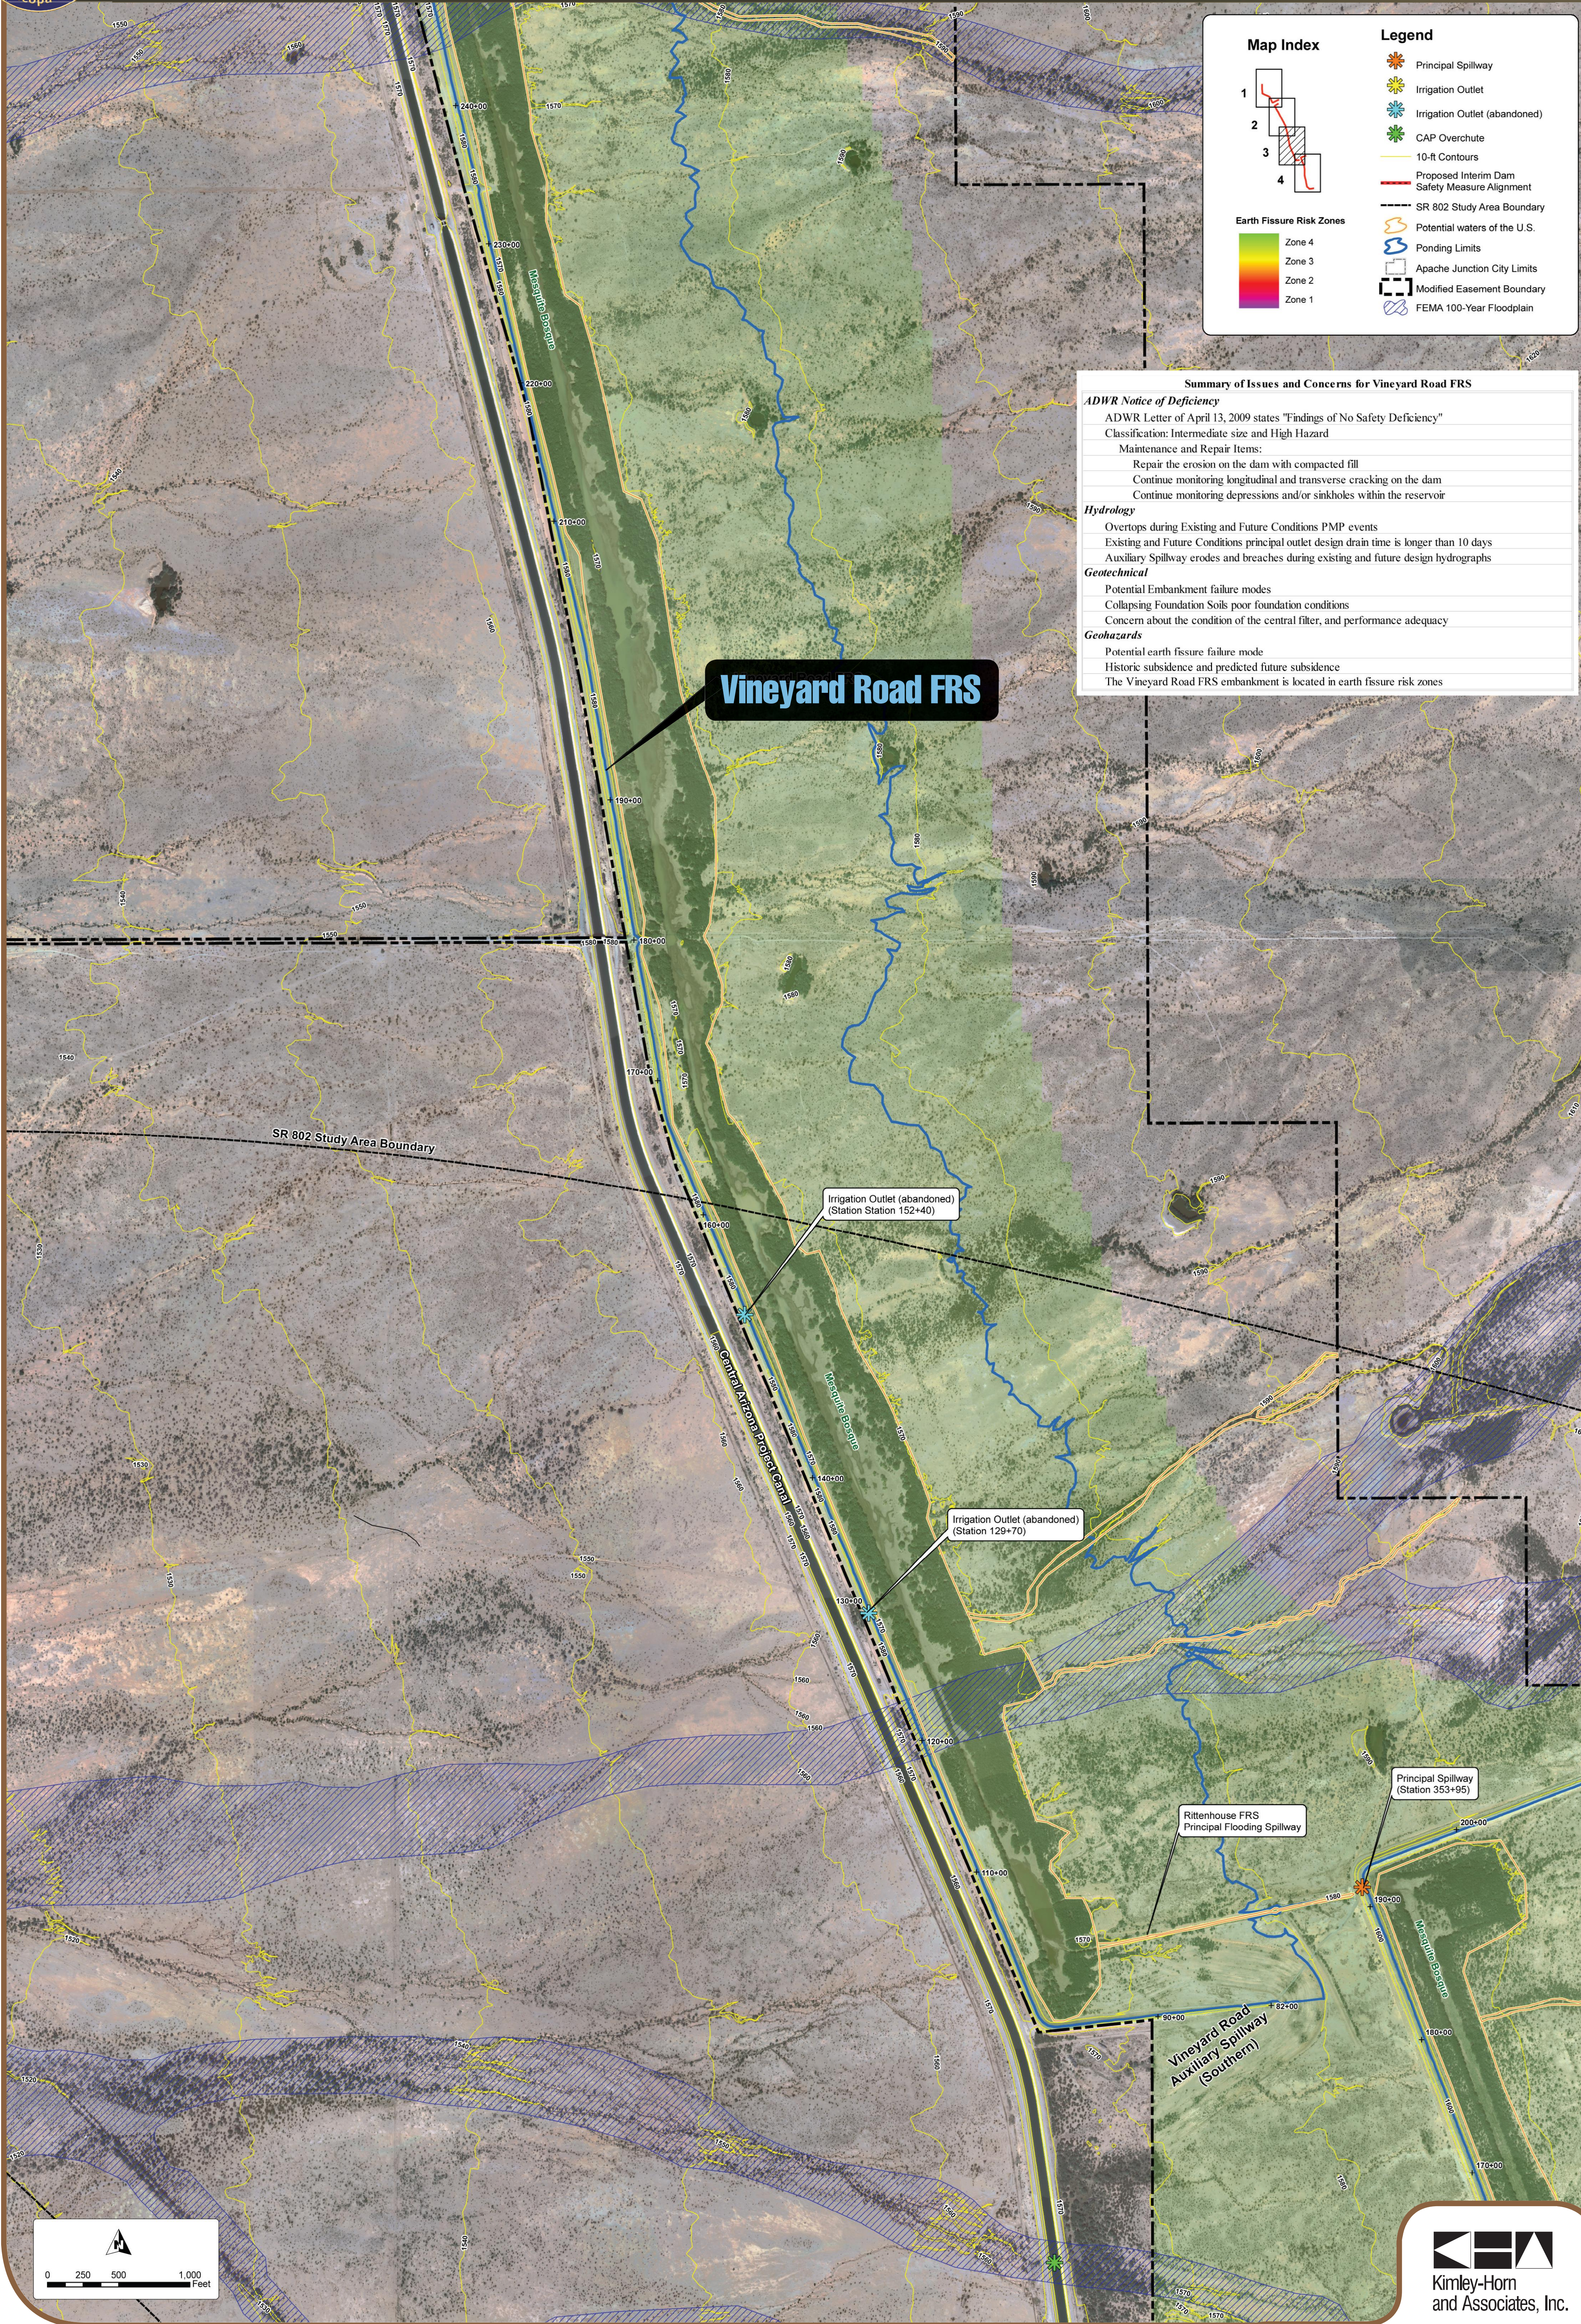
ADWR Notice of Deficiency
ADWR Letter of April 13, 2009 states "Findings of No Safety Deficiency"
Classification: Intermediate size and High Hazard
Maintenance and Repair Items:
Repair the erosion on the dam with compacted fill
Continue monitoring longitudinal and transverse cracking on the dam
Continue monitoring depressions and/or sinkholes within the reservoir

Hydrology
Overtops during Existing and Future Conditions PMP events
Existing and Future Conditions principal outlet design drain time is longer than 10 days
Auxiliary Spillway erodes and breaches during existing and future design hydrographs

Geotechnical
Potential Embankment failure modes
Collapsing Foundation Soils poor foundation conditions
Concern about the condition of the central filter, and performance adequacy

Geohazards
Potential earth fissure failure mode
Historic subsidence and predicted future subsidence
The Vineyard Road FRS embankment is located in earth fissure risk zones

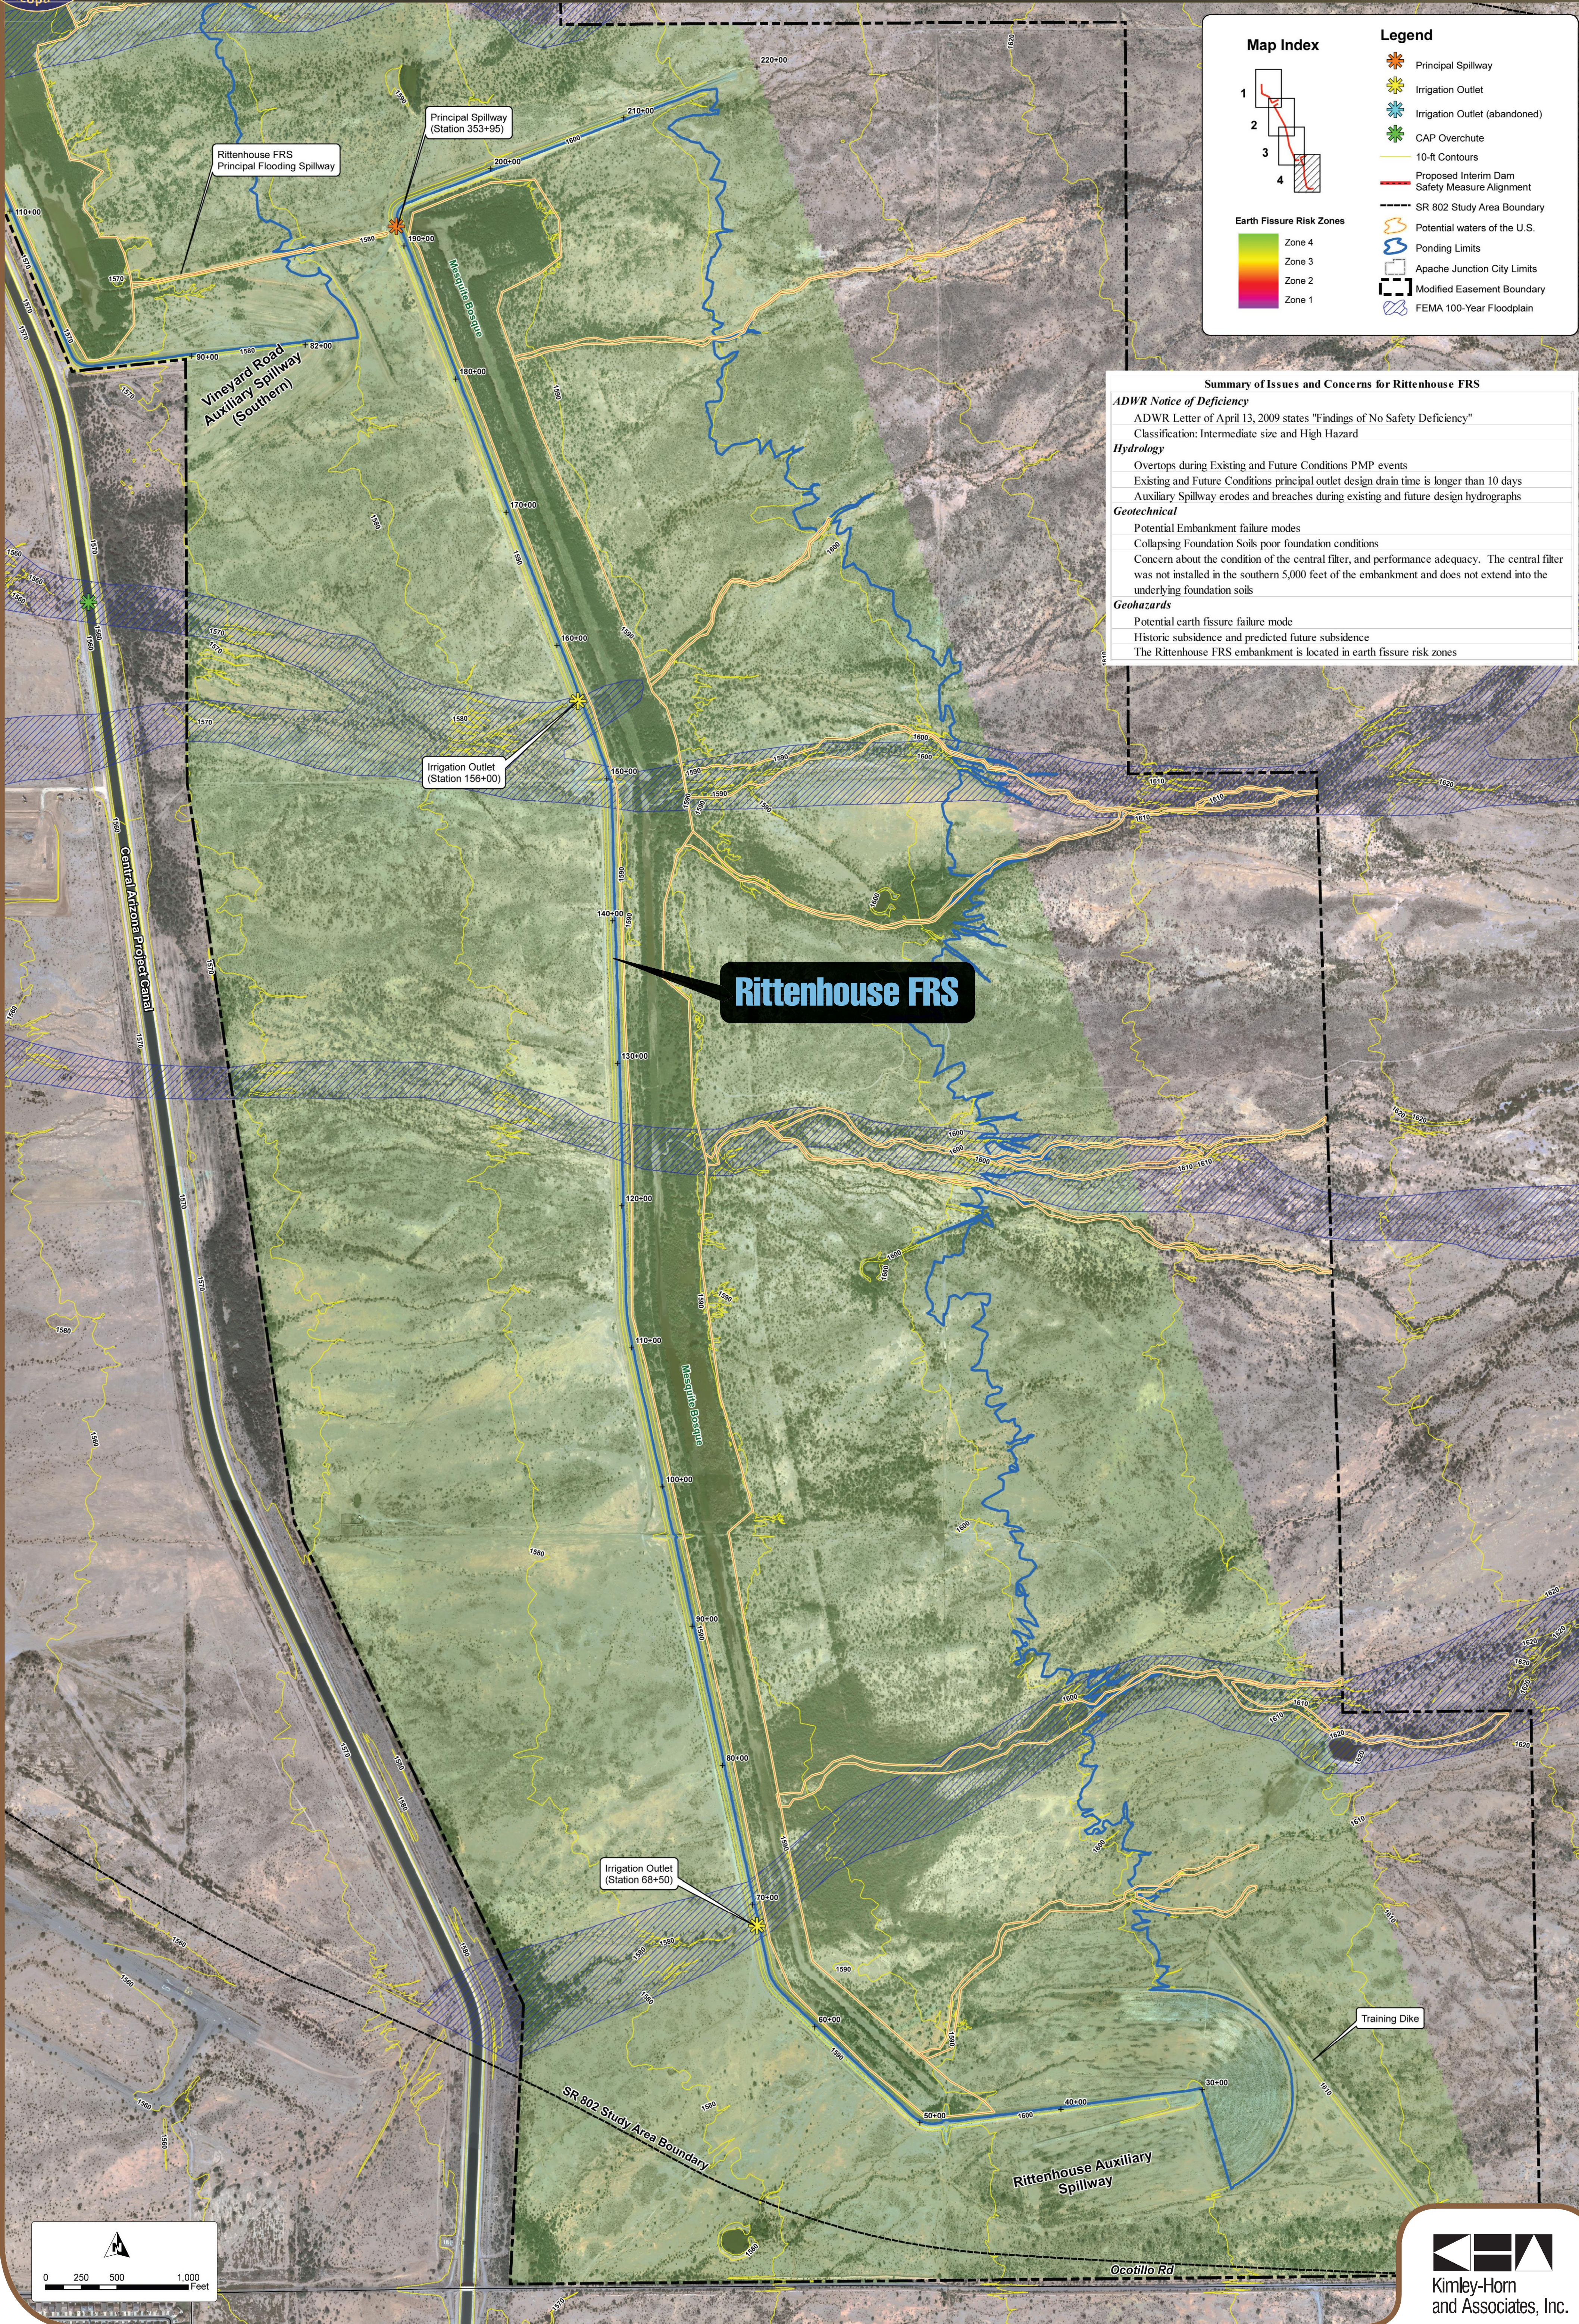
ADWR Notice of Deficiency	
ADWR Letter of April 13, 2009 states "Findings of No Safety Deficiency"	
Classification: Intermediate size and High Hazard	
Hydrology	
Overtops during Existing and Future Conditions PMP events	
Existing and Future Conditions principal outlet design drain time is longer than 10 days	
Auxiliary Spillway erodes and breaches during existing and future design hydrographs	
Geotechnical	
Potential Embankment failure modes	
Collapsing Foundation Soils poor foundation conditions	
Concern about the condition of the central filter, and performance adequacy. The central filter was not installed in the southern 5,000 feet of the embankment and does not extend into the underlying foundation soils	
Geohazards	
Potential earth fissure failure mode	
Historic subsidence and predicted future subsidence	
The Rittenhouse FRS embankment is located in earth fissure risk zones
